# **CHAPTER 11**

# Industrial Archaeology at Chocolá

Edgar Mendoza

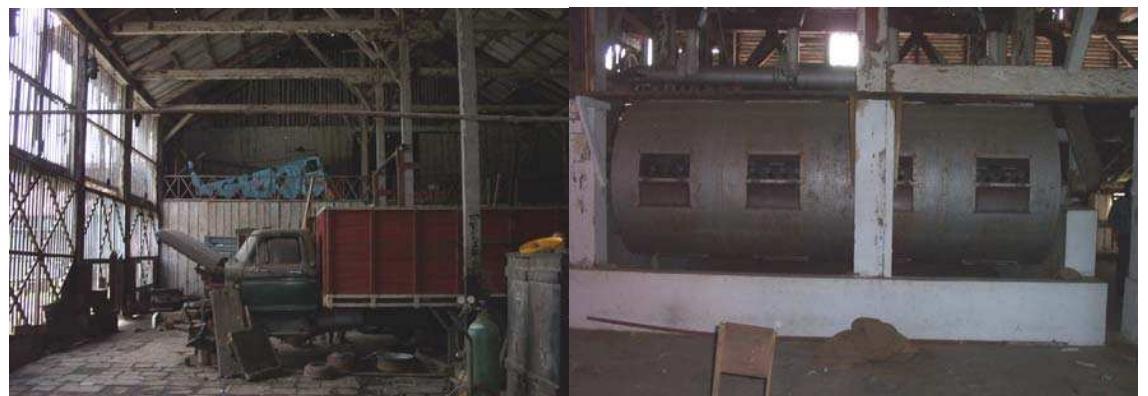
Fig. 11-1a, b: (a) The workshop; (b) Dryer, coffee mill, Chocolá.

The hydraulic dryers [**Fig. 11-1b**] are of a gray color, they have their pulleys and several pipes to carry the heat. The other dryers are of identical shape and size, with the exception of the remaining two that are electrical; they all have heat pipes, and each one of them has at its inside a series of flanges that carry and dry the heat. The floor is the original one, and the tracks of the carts that transported the coffee sacks are still in place. The hullers or peelers that were used for peeling the coffee beans are found at left, there are approximately seven small blue peelers, with their corresponding levers; the peeled coffee beans then passed to some sort of tray where they were picked. In this section there is an abandoned electrical gasoline engine used to set one of the machines in motion. Between these five dryers there is a space that may be crossed to reach a series of pulleys, belts, and heat controllers. Between the two electrical dryers and the other Guardiola machines, there is a space with abandoned tools; at the left there are pools where coffee was taken through a number of canals that dragged the coffee towards that sector for the corresponding washing.

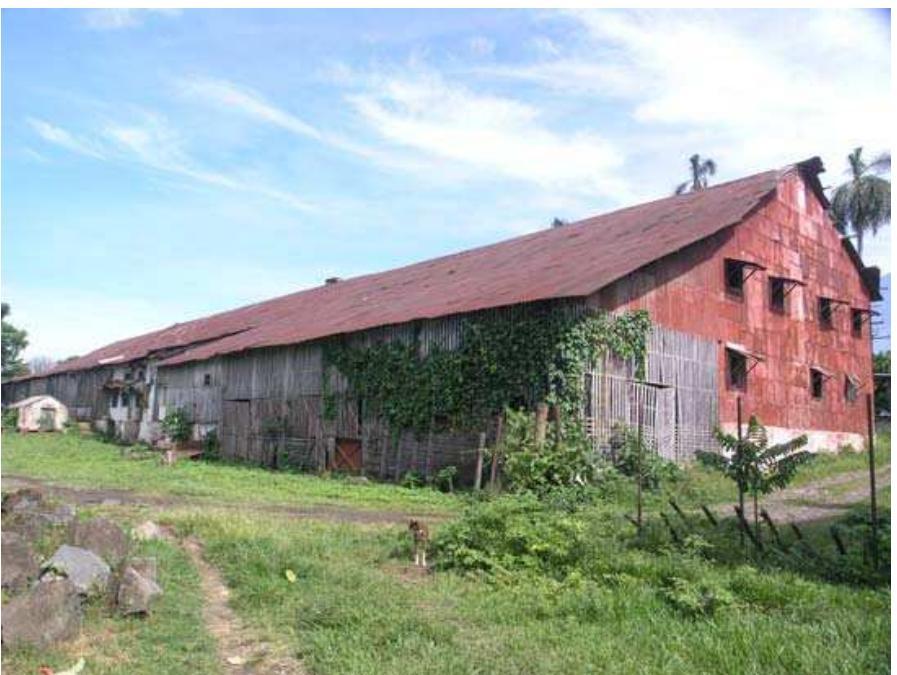
Fig. 11-2: Machine shop.

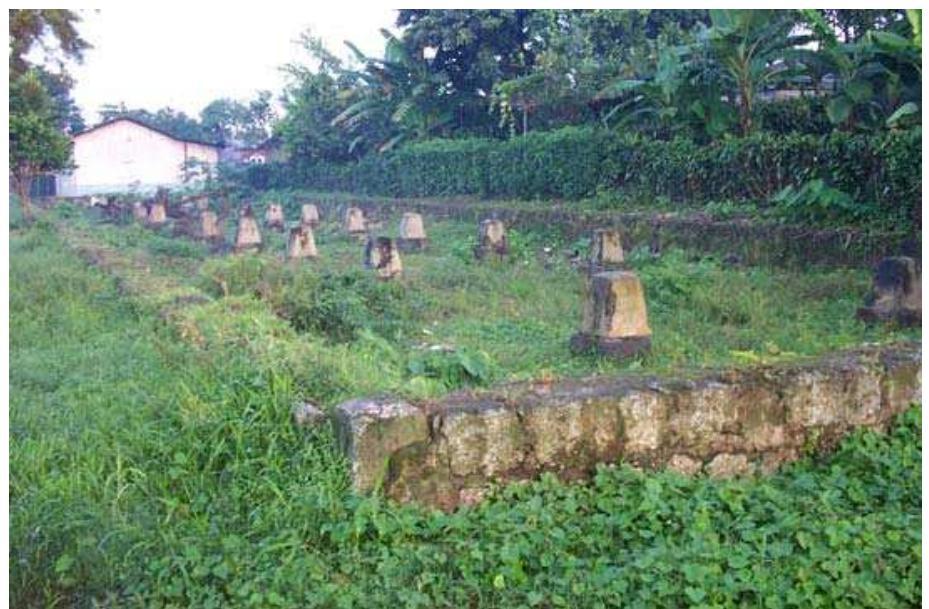
Fig. 11-3: Railroad remains, Chocolá.

The railroad [**Fig. 11-3**], the Cantel yarn factory, the soap factory, the Central American brewery and other smaller factories were simultaneously functioning in the 19<sup>th</sup> century in Guatemala, (Cifuentes et al. 1993). This substantiated the significance of machinery imports for the production of a specific product or as spare parts for the already existing machines. It also implied a better administration of all these machines and the products they yielded.

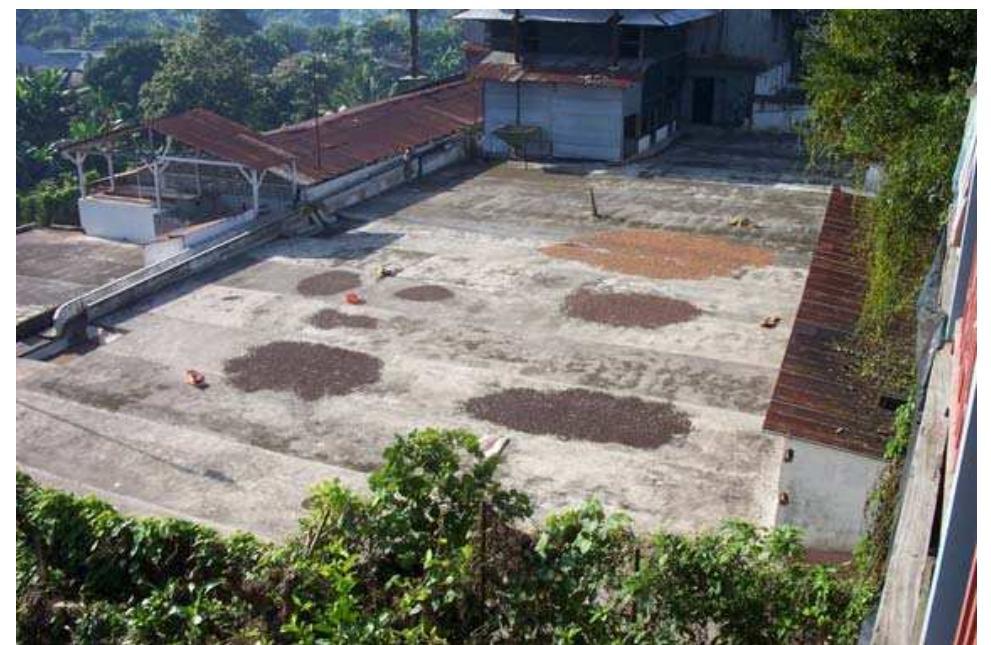
Fig. 11-4: Coffee beans drying outside the mill. After abandoning the coffee processing machines, people today have returned to less sophisticated methodology.

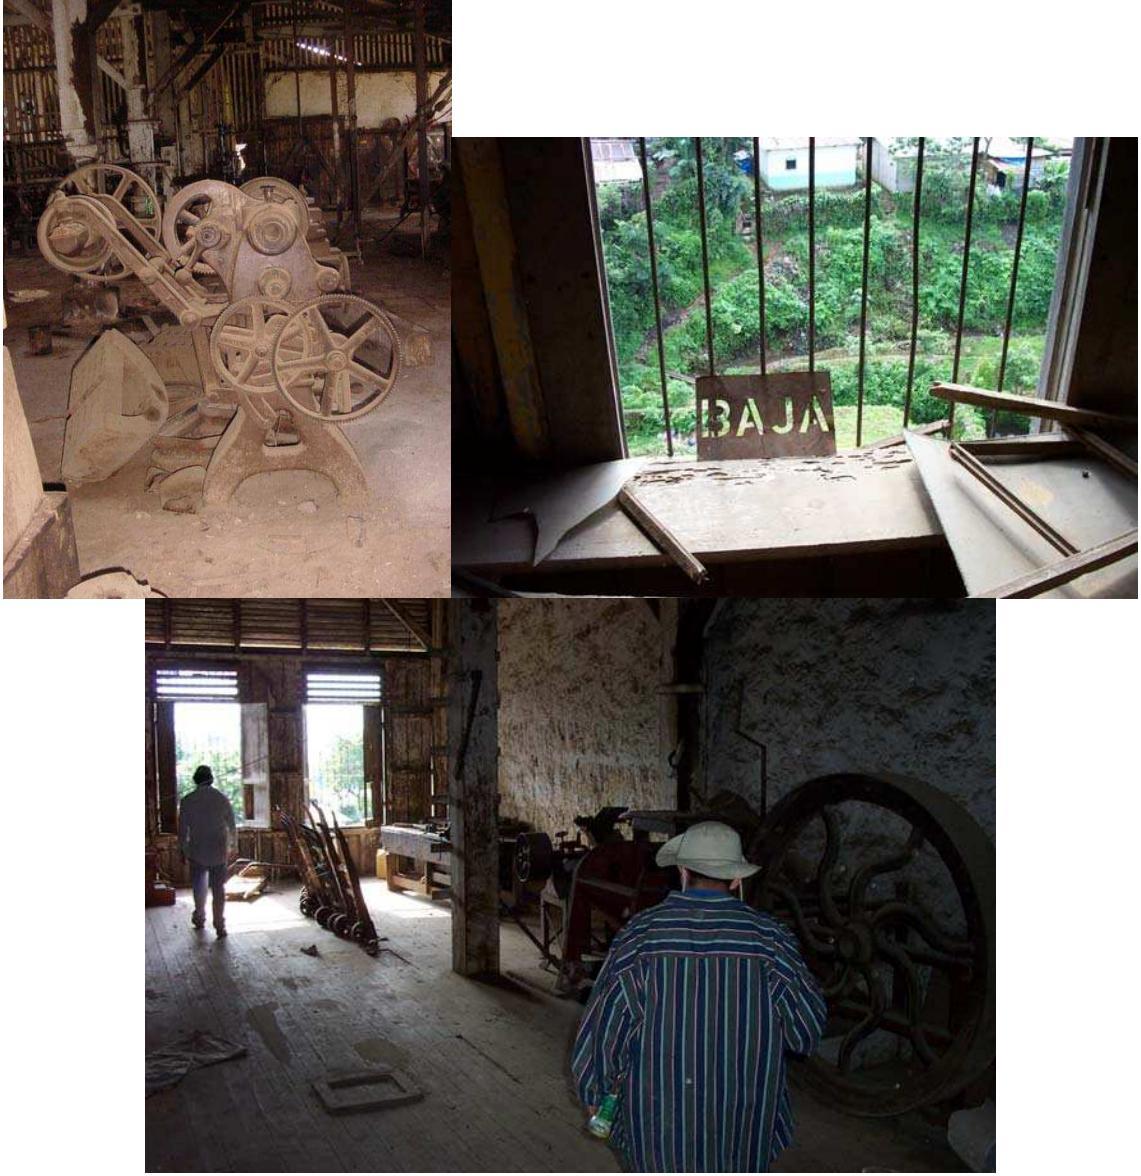
## Coffee mill [Fig. 11-a, b, c]

Fig. 11- a, b, c: Coffee mill, Chocolá.

Leaving the administrative central area of the property, from the black gate at the entrance that opens in two parts towards the inside and is supported by the two columns, the mill can be seen approximately 100 m away, and the machine shop, 60 m away. The building has a facade that is 86 m long and has several windows, a gray gate, the windows are orange, possibly painted later, it is a two-level building and the lower part has a kind of basement that leads to one of the major hydraulic machines. The mill has a water entrance at the south. The gate is old: adjacent to it there is an administration booth, and at left are the stairs that climb to the second level. In this first level we see the five Guardiola dryers, three of which are water powered, while the other two are electrical. The space shows several stout wooden pillars that support the second level. At the right side there are several tools, there are wheels close to the area where water is introduced. One sector shows the pulleys that control the speed of water, and there is a shaft that crosses the entire mill; there are numerous pulleys with their corresponding speed belts and levers, gear-changing levers and supporters, which are the ones that made the main shaft of the pulleys spin round.

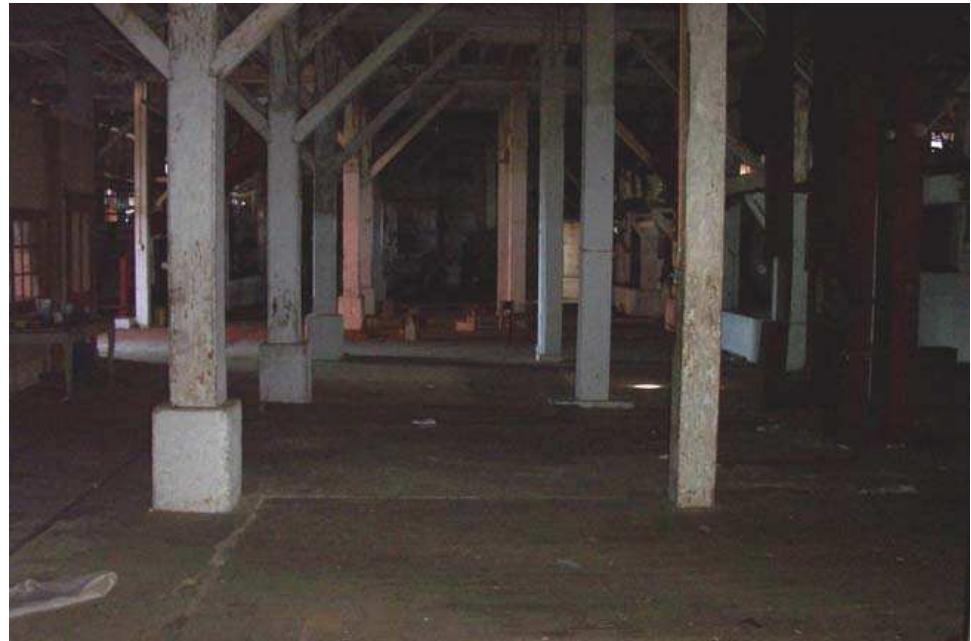
First level [Fig. 11-6]

Fig. 11-6: First level, Coffee Mill.

The first level already shows drying machines, and the abundant number of columns at the second level is remarkable; also the tracks are visible, running towards a ramp that opens to a gate, from which the small carts with coffee would set out. This upper part shows the blue peeling hullers with their water faucets, quite deteriorated but still fit to work. We may also observe the large amount of electrical cables that show the complicated power system of the entire mill. Once in the first level one may see the gate from the inside with its big hinges; in spite of its large size, this gate is of the sliding type. At the first level, if we go to the sector where water is introduced from the shop, there is a machine that moves the sluices, and there the powerful sound of water running down at a considerable speed to vertically fall on the other lower level (the cellar) can be heard. Opposite to the sluicing machine there is another one in the shape of a boat's steer, which is the one that controls the chain that maintains part of the sluice closed, and defines the velocity of the fall; the levers that were used

to open and close are visible from the first level; this machine located in the second level, to avoid the inconvenience of climbing to the first level, could simply be closed from the cellar below. We could also observe the machine that changes the belt by means of a lever. There are a number of abandoned machines with the following legend on their side: ATP Gs CrossWare McDermont Bucklaw, and there is also a very peculiar wheel with curved rays that resemble those of a sun, which is also some sort of pulley.

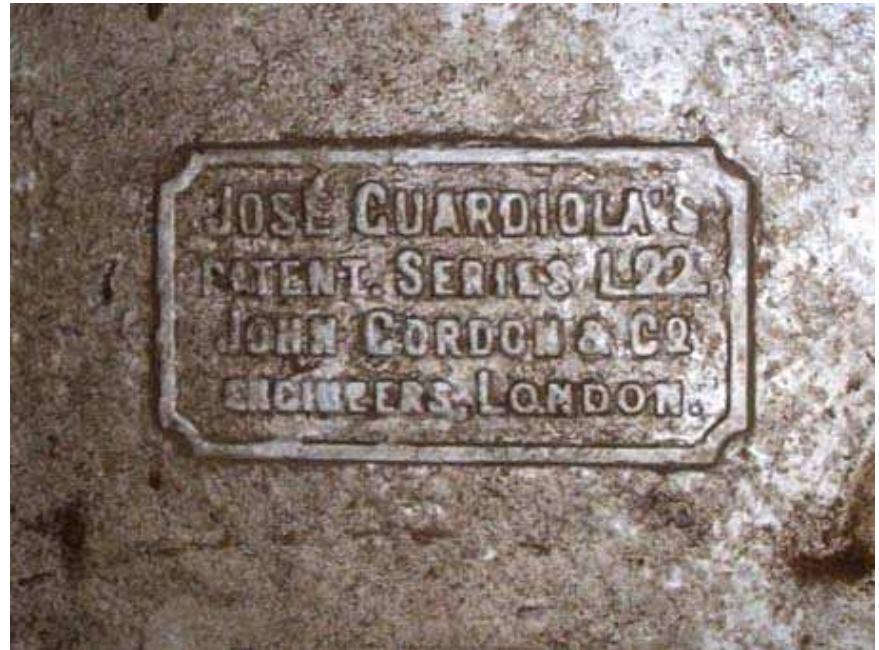
Fig. 11-7: José Guardiola's patent, Coffee mill.

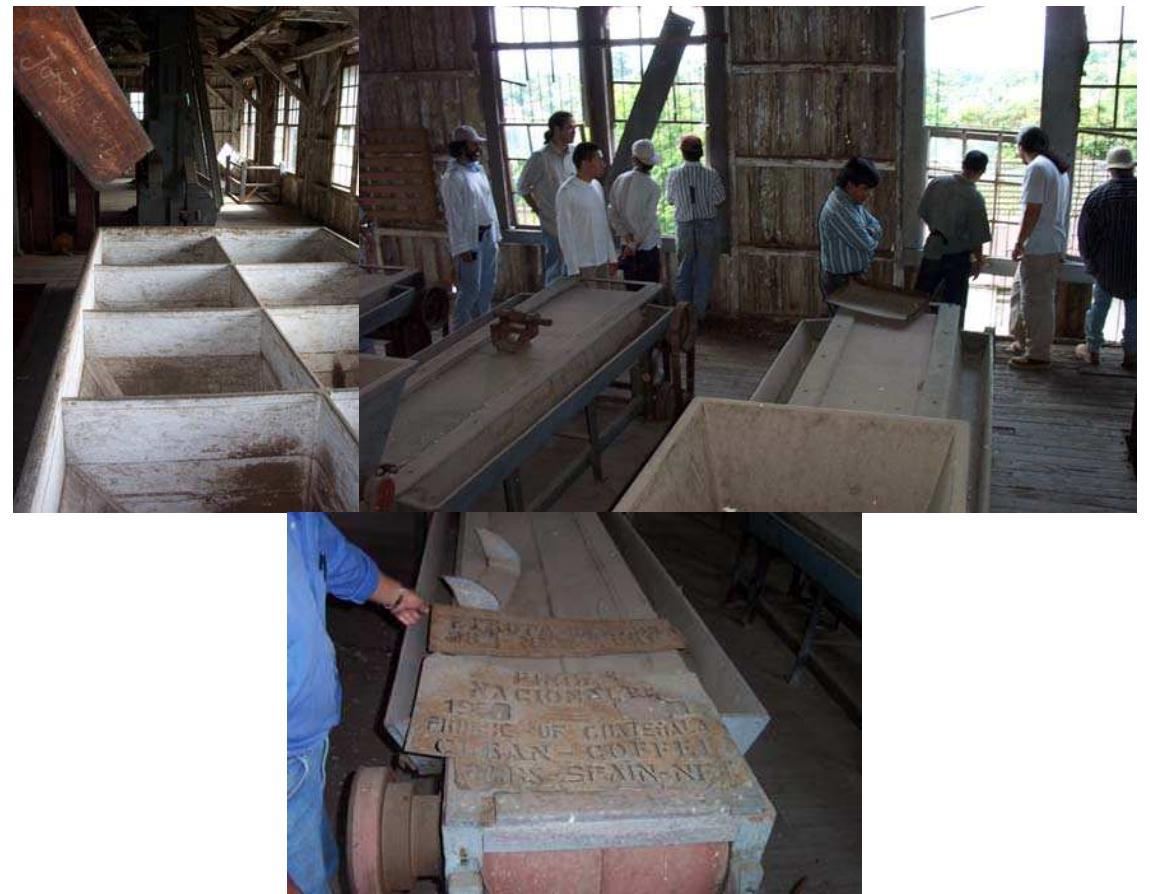
Second Level [Fig. 11-8 a, b, c]

Fig. 11-8 a, b, c: Second level, Coffee mill.

Before reaching the second level there is a small intermediary level between the first and the second that architects call mezzanine, which houses several machines painted in a silver color and include their corresponding inventory numbers; there are dispersed wooden pulleys, water powered engines which read John Gordon and Company, London, several heat conduits, and one machine manufactured by Kinon Limited and Engineers, Haverten, Scotland; therefore, there are English, Scottish, U.S. and German machines. The structure where all these machines are located is made of tough wood painted white, a bit damaged by the moths, but the blocks are stout, there is a pulley at about the middle of the structure, bearings to provide pressure to the pulleys, and major quite strong wooden pulleys. They all have a number, and probably there are 100 pulleys of varied sizes that once controlled the entire mill. There are coffee falls as well, and one machine that reads D. Engelbert Huel Company, Syracuse, New York.

Climbing the steps to the second level there is a first landing; the steps are painted red. The second level has a more ample spatial distribution than the first. The second level has administrative and storage spaces. There is a large storage room with wooden doors and bars to the right, another large room to the left, and the coffee falls in the middle. The metallic, square shaped falls correspond to the modern electric dryers, and the other ones made of old wood, correspond to the Guardiola water powered dryers. There is a machine also used to refine coffee, with a logo that reads: CL Limited, in a golden color, and there are cleaning machines with factory names such as John Gordon and Company, London [**Fig. 11-9**], displaying in Spanish: Size No. 2, 11081, London Pulley 75 Revs for Minute (revolutions per minute), John Gordon and Company, London. There are many old wooden pulleys that still work in this level; the colors of the machines are different

grays, and the coffee falls are painted white. The north profile shows a section that has been added on, where the red dryers are located; this addition was built in the 1960s', and then there is the yard for the outdoors drying of coffee, which is the original one.

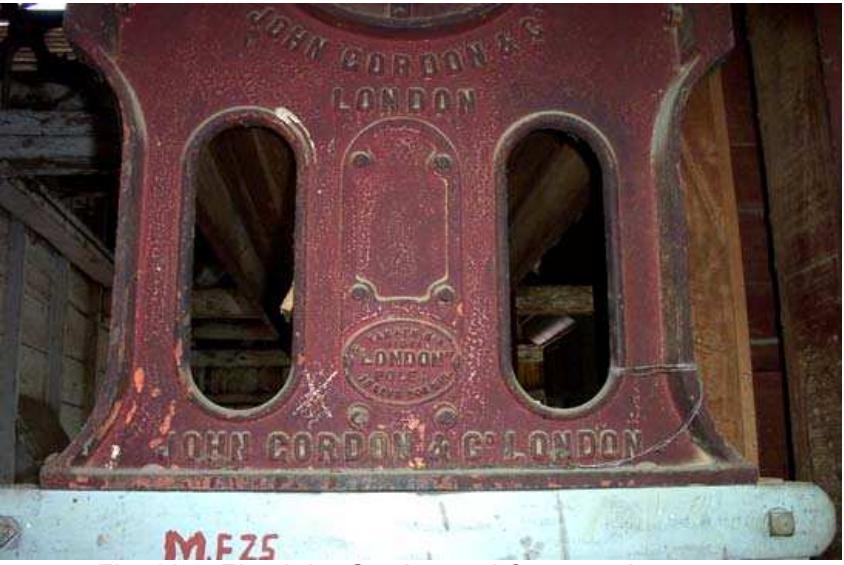
Fig. 11-9: The John Gordon and Company's patent.

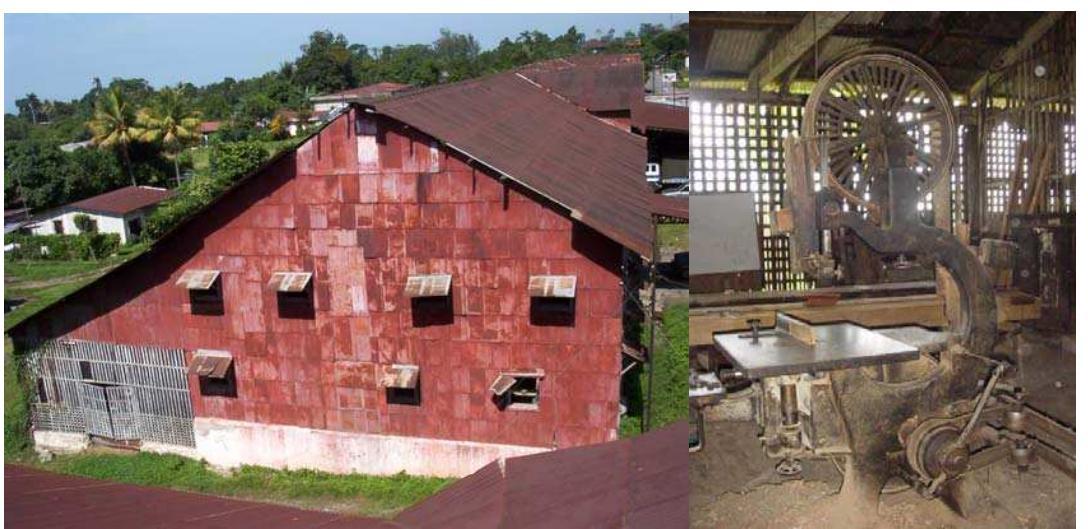
Machine shop [Fig. 11-11 a, b]

Fig. 11-11 a, b: (a) Machine shop.

Standing in front of the shop we can see the mill's façade and the shop to the left; from the front, the machine shop looks very deteriorated, it is completely made of wood, with very little metal structure just like the mill; the old tower can be seen where the clock used to be located, it has a few very decorative edges, as does the following tower with its bell. The store is to the left. Standing in front of the two columns at the entrance of the central area of the property, we can see the shop with different sheet metal and wood windows. There is an old picture on what apparently is a concrete wall, but in fact it is wood or sheet metal, painted white. To the west one may see the feeder canal that carries water from the upper sector of the community and takes it straight to the Pelton wheel inside the shop, then it passes underground across the shop and reaches the mill at an increased speed, due to the slope of the terrain.

From the shop's entrance and to the right, the water powered Pelton wheel is visible, while to the left there are a series of spaces that house unused trucks. There are two rooms in the back that function as a small warehouse. There is a large table, together with a number of old tables close to the entrance. There are three presses on the left, and a back room on the left side which is the store, with two levels. Near the right rests the machine used to bend the canals or to manufacture the metal canals (card 11). We may see here the entire electrical structure, formed by old cables. This space has approximately 14 columns. Then there are a number of closets for the forge, with numbers on small plates, 5.36, and there is a closet with lathes, where there are compasses, files, screwdrivers, spare parts and chains. The last two closets contain electricity materials.

Each sector has its own closets, for example the lathes section has its own closets. Then there is the forge (card 3) where iron is melted, one anvil, the original floor, cement squares, large presses, and all the lathe machines. There is as well an air engine, and the crucible to receive the liquid metal. We may also observe the lathe machines (cards 1 and 2), in the same manner, in the upper part there is a number of shafts with approximately 40 large pulleys. We have the lathe machine (card 8), greased and functioning, and the drill (card 5), and adjacent to them on the floor there is a number of spaces covered with wood where the water runs below. There are five wooden lids that cover the lower part. Then we see the master lathe (card 2), the largest of all lathes. On the floor there is grease, oil, as well as pieces of wood and metal, dispersed across the shop area. The area of the machine used to fix

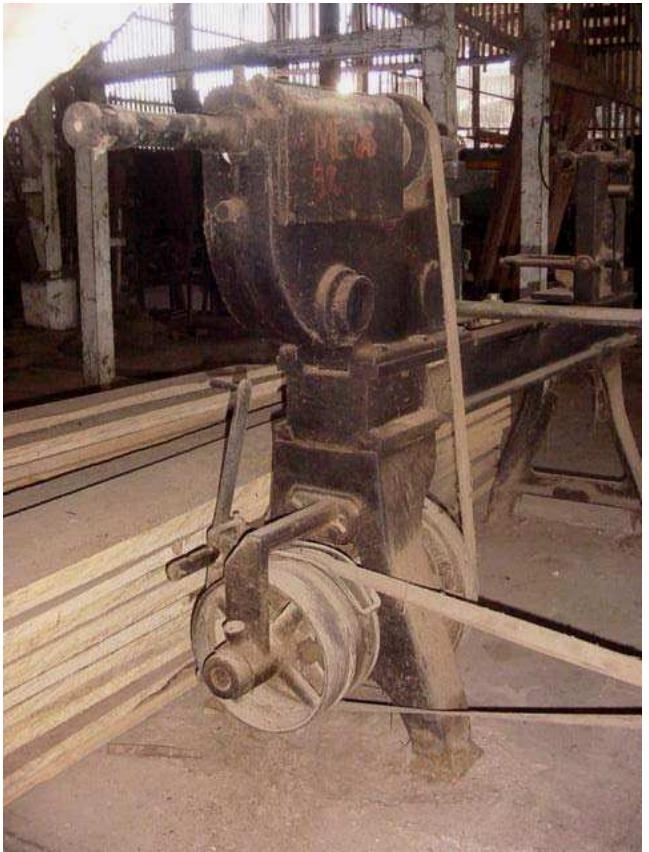
Carpenter's shop [Fig. 11-12]

Fig. 11-12: The carpenter's shop.

We will now describe the carpenter's shop and/or sawmill. Some young men are currently taking a carpentry course in this area and they go there to practice using the machines. In the sawmill area there are several loose, abandoned pieces. Looking up, we observe that the entire shears structure is made of wood with metal sheets, the master wooden pillars support the roof, and there are tall squares. The sector is large, it shows scattered pieces, as well as belts and machines in use. This sector houses the machines (cards 9 and 10). From the southern sector we may see the machines in perspective, with the pulleys spinning round, and most of the beams show spider webs and rusted sheets. This sector has a gate through which wood was introduced, and there is a machine with a track where wood was placed (card 14) and transported to the saw. This sector is abandoned, and a ramp used to carry the wood still exists. If we stand in front of the ramp in a straight line, we may see the space where timber was stored outside this sawmill to be later removed and cut, so this entire sector is covered with timber refuse.

The place is quite abandoned, and there are remains of timber, metal, tables, bamboo, unused planks piled up and destroyed, the sawmill machine is entirely deteriorated, dirty and neglected; there is a machine made in Vermont, and the saw (card 14). This sector is quite abandoned; there is a wheel on a wall, with an approximate diameter of three meters, and some steps that lead to an added space

where there is one machine with two pulleys. On the opposite side there is an entrance, the floor presents parts with the original stone, and everything looks somewhat deteriorated. On the floor, there are a number of small wheels used to run the track. There is a small room between the two pulleys with another abandoned machine, precisely the one that was used to bring the timber. It is said that one individual sat on the machine to direct it towards the direction where wood was to be transported; the machine has lost one of its pulleys. This machine, used to pull timber, displays initials on its left side which read: CH JUCHO 689, and on the opposite side it reads: 37; these initials were imprinted in the metal, they are not a scrape but an incision, and are filled with grease and oil. In this southern sector there is a lateral gate, with an original metal base and a sheet of a circular crank; this gate is quite old, and close to it there are some pieces of wood, some hullers used in the mill, heating tubes, etc. In short, this sector has become a depot for refuse materials and remains of useless machines.

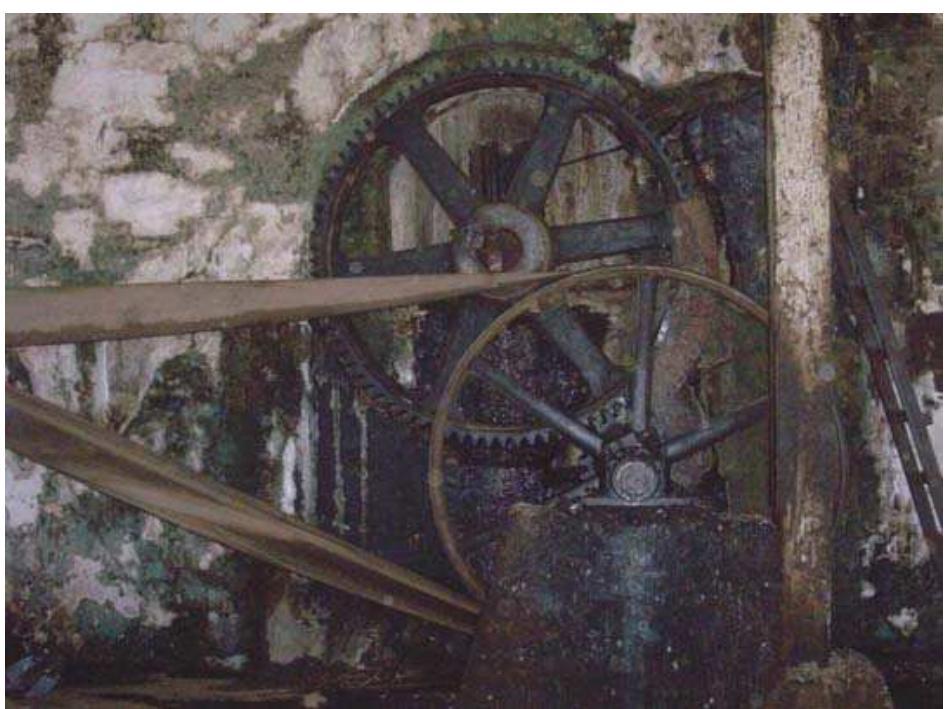
Pelton wheel [Fig. 11-13]

Fig. 11-13: The Pelton wheel.

The Pelton wheel (card 13) has an approximate diameter of 10 m, and powers three belts, by spinning a shaft full of pulleys that crosses the entire shop. The Pelton wheel has a concrete base covered with a sheet, the wheel cannot be seen, but there is one position where a part of it is visible, and it is a wooden wheel with a small square hole, where one may see the wooden wheel with steps where water is deposited, spinning around; the main pulley that pulls the entire carpentry sector has a belt of at least 10 m long, several wooden pulleys simultaneously spinning around; the pulleys, because of their use, are quite clean, shiny and silvery. On the opposite side of the wheel is the carpentry sector; from that point the two wheels may be seen, two pulleys and the two gears that make the Pelton wheel spin round, this is visible from the side opposite to the one where we described the concrete base of the wheel, or the side of the carpenter's shop.
